# Manhole Inspection Summary

Manhole # S33O1\_007MH

Insp Date: **2/5/08 7:54 AM**

**Location** Address: **3031 Ascension St**

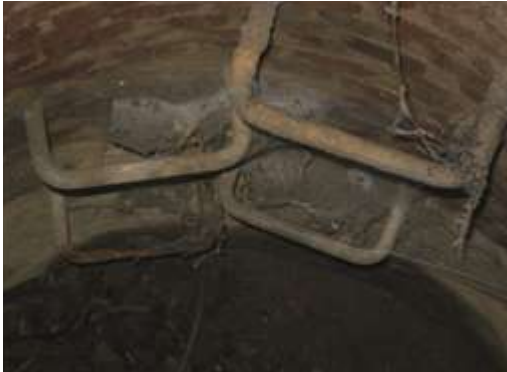
steps

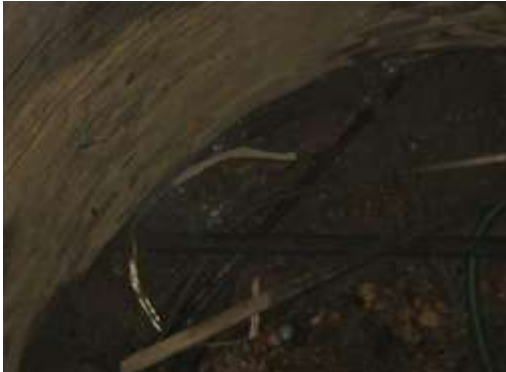
Defect 2

debris

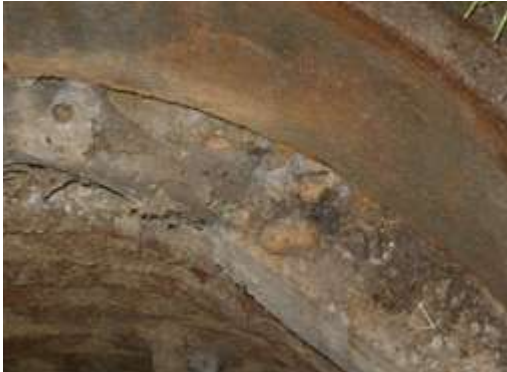
Defect 1

Condition: ☐ Sound ☐ Cracked ☐ Root Intrusion ☒ **Loose Brick** ☐ Deteriorated

loose bricks on chimney

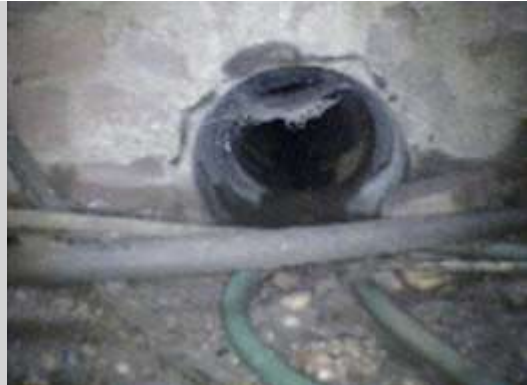
12 O'Clock Outflow

8 in. Circular Gravity Sewer  
Pipe Out @ 12 O'Clock
